Manhole Inspection Summary

Manhole # S33KK_047MH

Insp Date: **11/6/06 8:47 AM**

Location Address: **1805 LOVEGROVE ST**

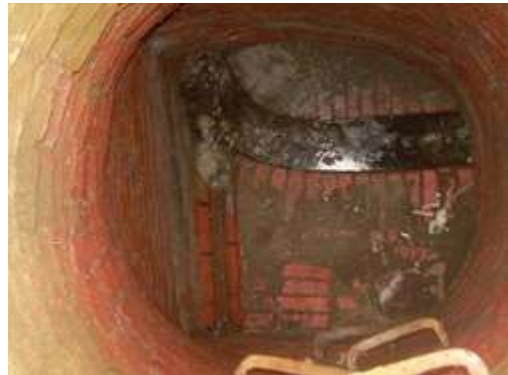
Top View

Adjustment, Corbel and Barrel infiltration. Corroded steps. Evidence of surcharge - Bench debris. Channel debris.

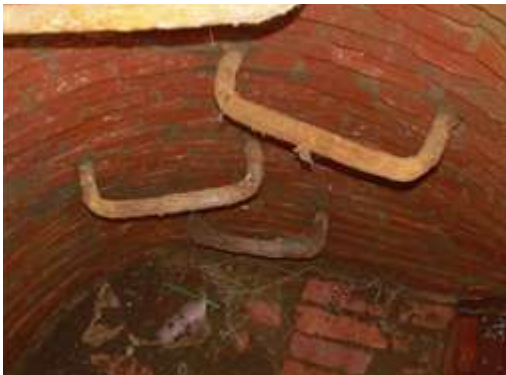
Defect

Barrel infiltration. Corroded steps.

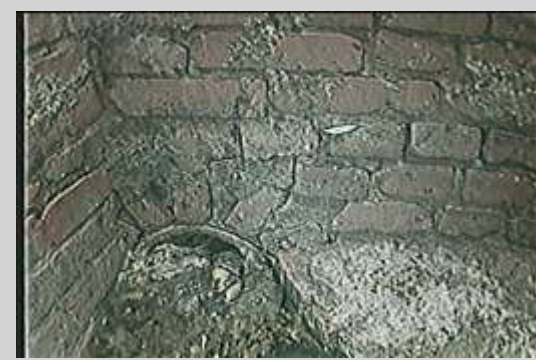
Pipe Out @ 12 O'Clock

pipe full of debris

Deposits: ☐ None ☒ **Mud** ☐ Sludge ☒ **Debris** ☐ Grease

Silt Depth: **6** (in.) Deposits Extent: **Heavy**

Infiltration: **Evidence** Pipe Seal Cond: **Cracked**

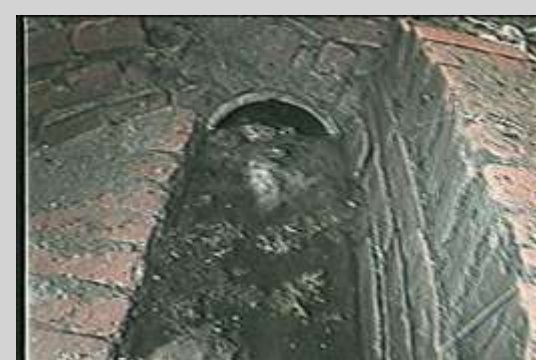
Pipe In @ 3 O'Clock

Deposits: ☐ None ☒ **Mud** ☐ Sludge ☒ **Debris** ☐ Grease

Silt Depth: **6** (in.) Deposits Extent: **Heavy**
